Jefferson Place Villa Community

Pedestrian Bridge Review Report

ENGINEERING
RESOURCES, INC.

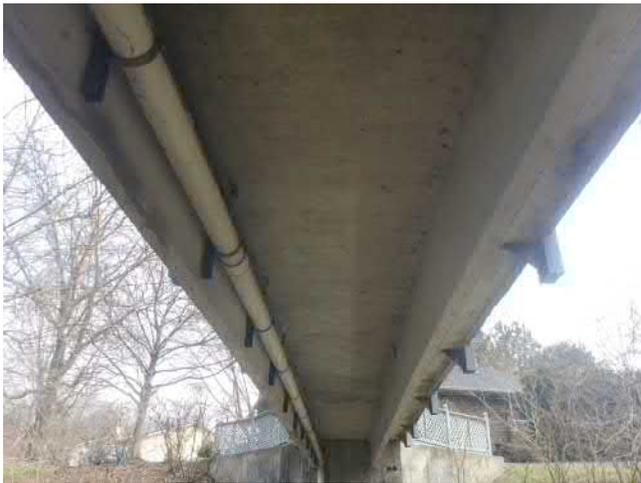
VIEW FROM BELOW - LOOKING EAST

The bridge is a single span prestressed concrete double tee beam bearing on cast-in-place concrete abutment walls. In addition, there appears to be a two-inch cast-in-place concrete topping installed on the precast double tee.

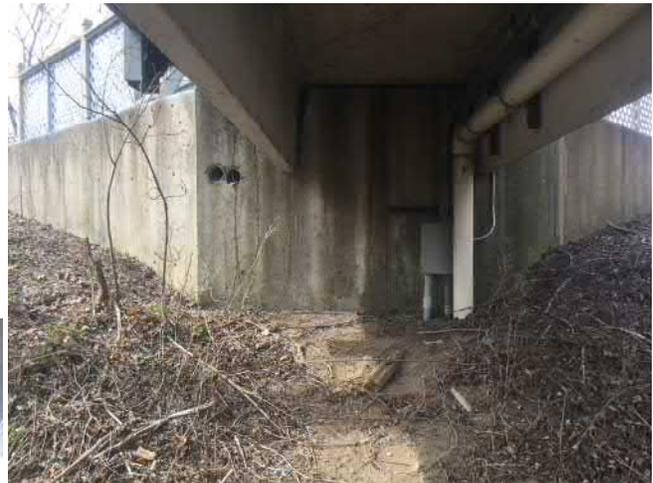
VIEW FROM BELOW - LOOKING WEST

The bridge span length is approximately 56 feet out to out. The deck width (walking surface) is 6'-9" which is also the distance between the hand rails.

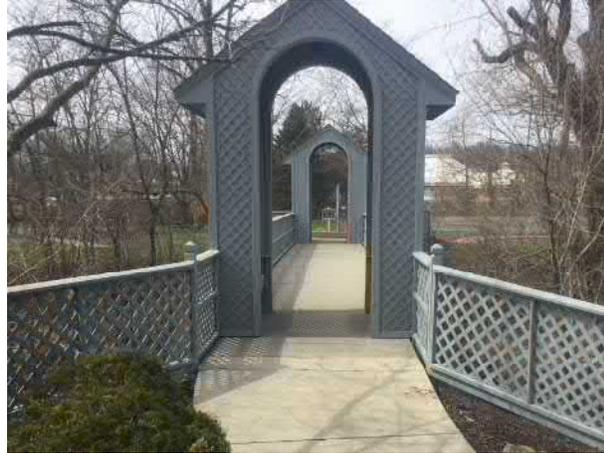
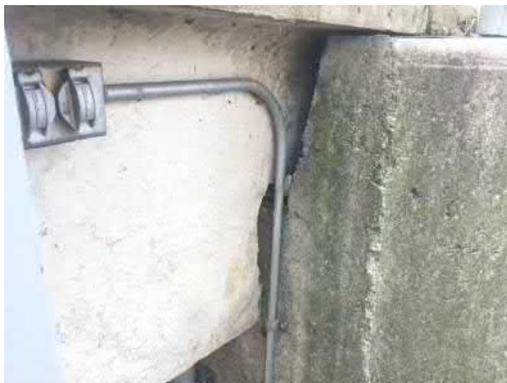
The useful width of the bridge is limited by the entry features that are included at each end of the bridge.

These features have an opening width of approximately 4 feet. Therefore, only pedestrians and vehicles/equipment, with width less than 4 feet, can use the bridge.

The stems of the double tees are dapped meaning they are notched at each end. This is a typical design for a parking garage double tee floor system where the stems fit into a pocketed spandrel beam.

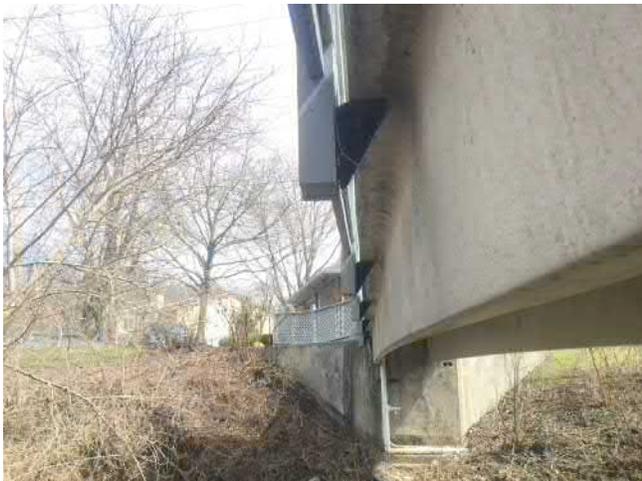
NORTH SIDE OVERHANG

In addition, the cross section of the double tee is not symmetrical. The north side has a 6-inch overhang while the south side has a 21-inch overhang. The double tee appears to have been a standard 8-foot width. It appears that 15 inches of the north top flange was removed. It's unclear if this was intentional.

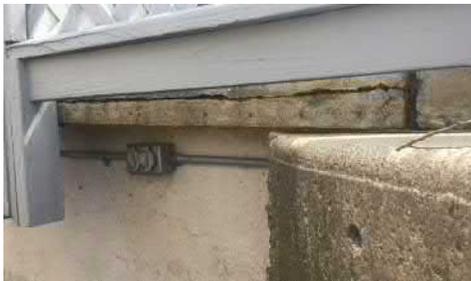
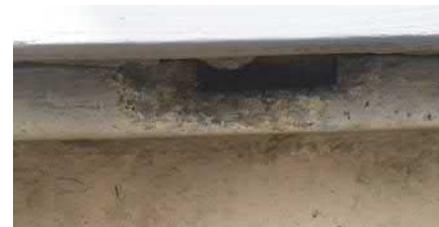
There are several locations where the superstructure shows signs of minor deterioration. There is a steel plate insert in the top of the flange, under the railing edge, that is exposed.

While these are currently minor, once steel corrosion is visible, the condition will likely advance more rapidly.

There are several conditions, identified in this report, that warrant maintenance work to ensure proper long-term performance of the bridge. These include substructure armoring, superstructure repairs, patching and/or sealing and railing/entry feature improvements. Repair details are beyond the scope of this report.

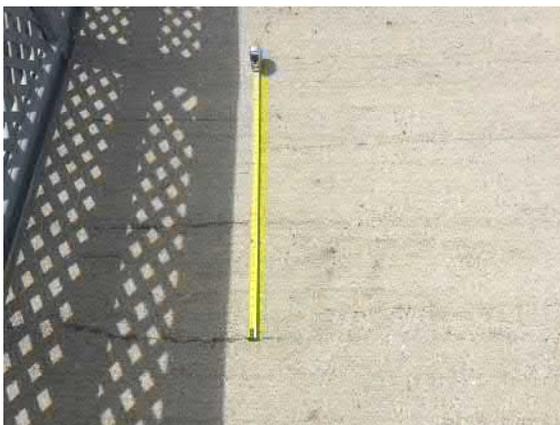
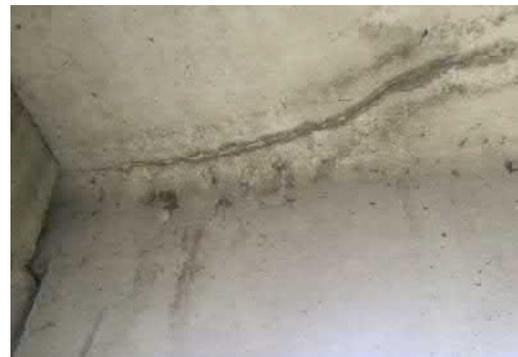
The top flange has a longitudinal crack between the precast tee and the cast-in-place topping at the end of the bridge. There is also exposed reinforcing steel which appears to be at the cut where the section of top flange was removed.

There is diagonal cracking in the top flange at the end of the bridge adjacent to the tee stems.

Finally, there is exposed reinforcing steel in the top of the flange topping visible in the walking surface which is probably due to inadequate cover.

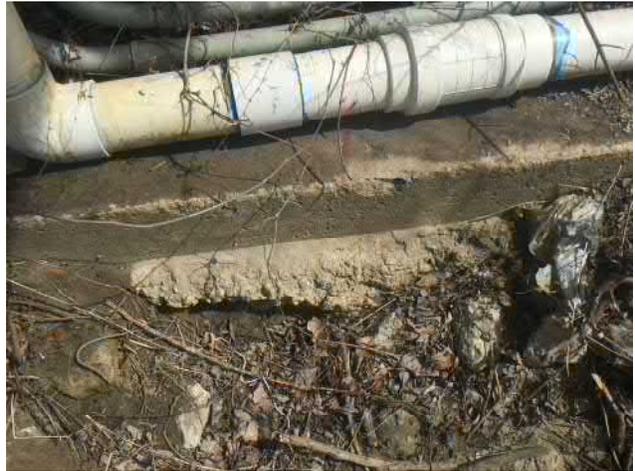
On the east side of the stream, there is some erosion and undermining of the abutment foundation. It's difficult to determine if this is related to stream scour or if the utilities attached to the abutment contributed to the condition.

Regardless of the cause, we recommend protecting the base of the foundation with 18 inches of revetment riprap over geotextiles in accordance with the requirements of the Indiana Department of Transportation (INDOT) Standard Specification. This will armor the foundation against erosion and scour damage to ensure proper performance in the future.

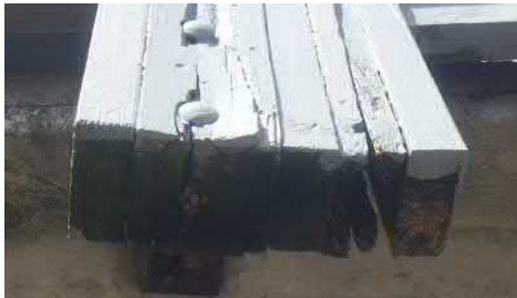
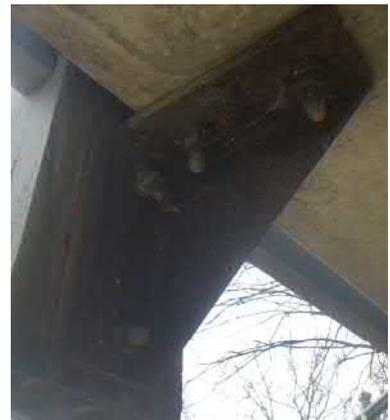
First, the railing connections are corroding and the ends of the vertical railing posts are deteriorating and have split. The railing is somewhat loose and is sagging between posts.

The distance between railing posts is approximately 8 feet which is possibly longer than the capacity of the top handrail component. The conditions of the railing should be reviewed in more detail and upgraded as required.
