Jefferson Place Villa Community

Pedestrian Bridge Review Report

ENGINEERING
RESOURCES, INC.

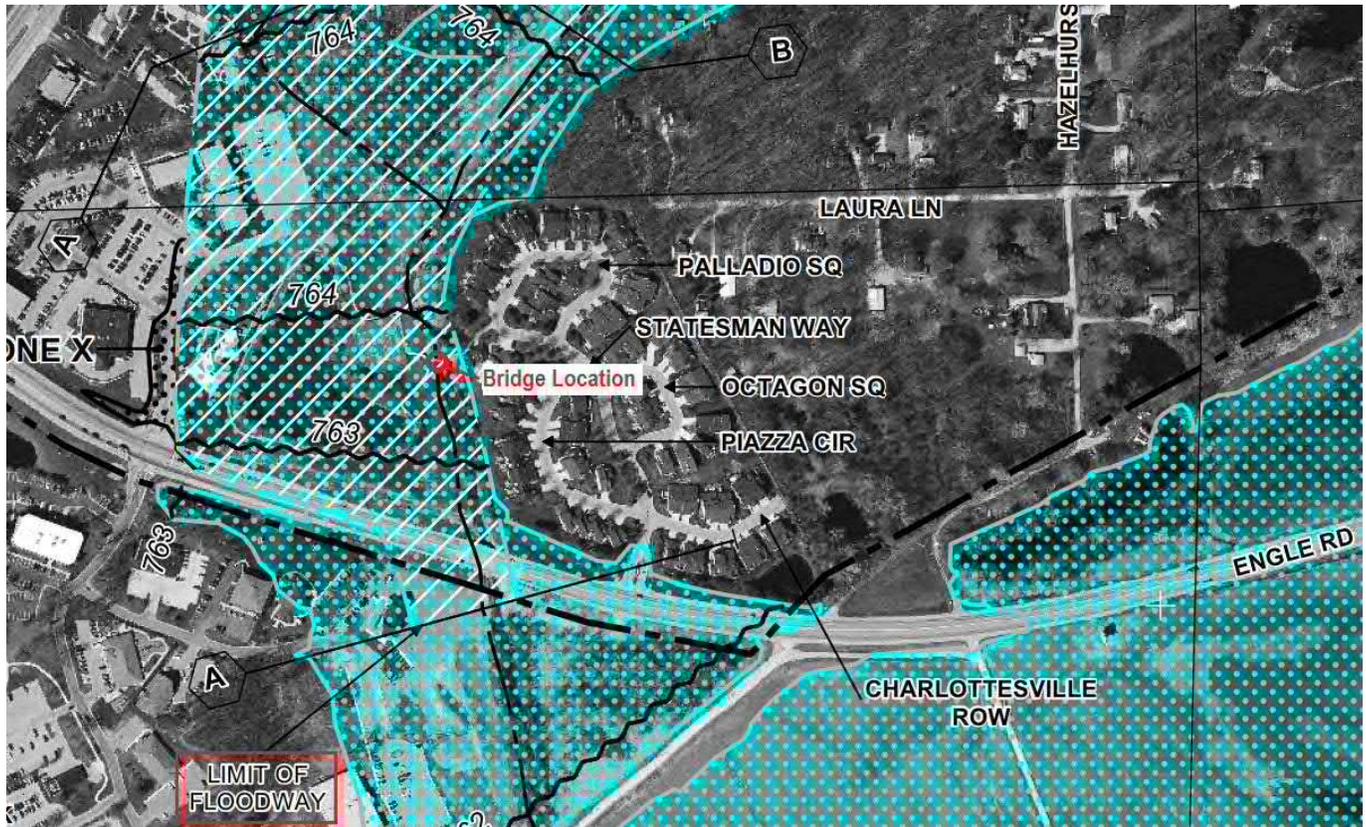
According to the National Flood Insurance Rate Map (18003C0286G), issued by FEMA, the bridge was constructed within the Floodway of the Graham McCulloch Ditch.

We reviewed the Flood Insurance Study for this stream, and the bridge was not included in the latest version, August 2009. The Indiana Department of Natural Resources, Division of Water, is responsible for permitting all construction within the limits of a Floodway for the state.

The IDNR website includes hydraulic computer modelling for all Floodway permits issued. We completed a review of this data and did not find any record of this bridge being approved by the Division of Water. It is possible this was constructed without proper permitting and is therefore in violation.
